# Manhole Inspection Summary

Manhole # S41I\_\_008MH

Insp Date: **5/14/08 1:57 PM**

**Location** Address: **1300 bank st**

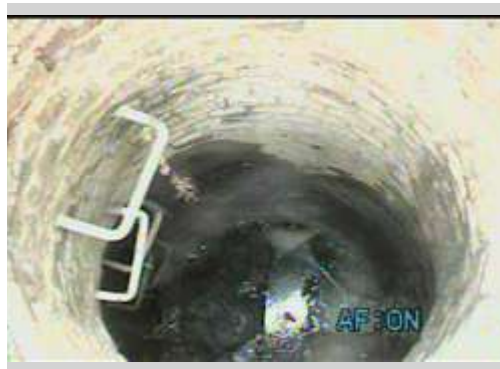
Top View

top view and steps

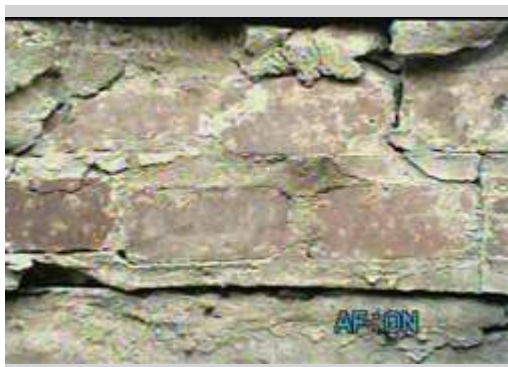
Defect 1

☒ Exists Material: **Brick and Concrete** ☐ Parged Height: **5** (in.)

Condition: ☐ Sound ☒ **Cracked** ☐ Root Intrusion ☐ Loose Brick ☐ Deteriorated

frame adj

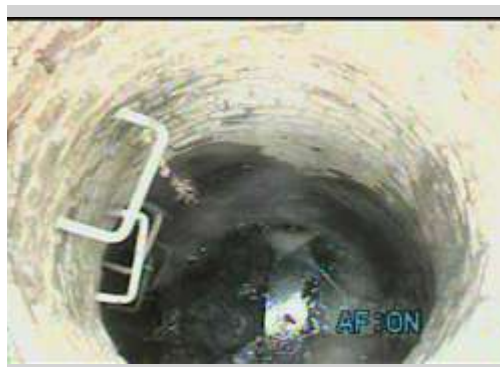
Defect 3

Condition: ☐ Sound ☐ Cracked ☐ Root Intrusion ☐ Deteriorated ☐ Leaks ☒ **Debris**

☒ **Evidence Of Surcharge** Depth: **5** (ft.) ☐ Active Surcharge Present

bench debris, surcharge evidence

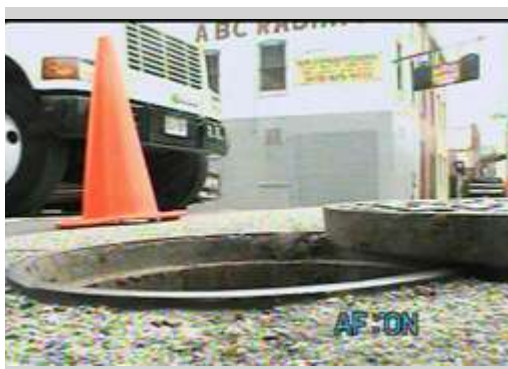
Defect 2

Diameter: **25.** (in.) Length: **0** (in.) Dist A/B Grade: **1** (in.)  
**5**

cover above pavement

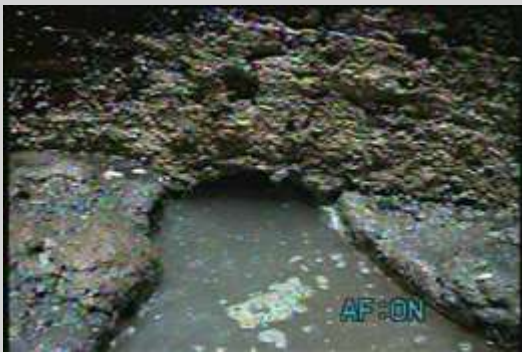
12 O'Clock Outflow

8 in. Circular Gravity Sewer  
Pipe Out @ 12 O'Clock

Pipe Material: **Clay** ☐ Pipe Lined

Invert Depth: **10.29** (ft.) Flow Characteristics: **None**

Infiltration: **None** Pipe Seal Cond: **Unknown**

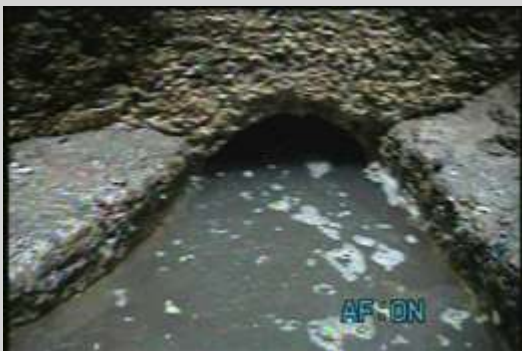
3 O'Clock Inflow

8 in. Circular Gravity Sewer  
Pipe In @ 3 O'Clock

Pipe Material: **Clay** ☐ Pipe Lined

Invert Depth: **10.19** (ft.) Flow Characteristics: **None**

Infiltration: **None** Pipe Seal Cond: **Unknown**

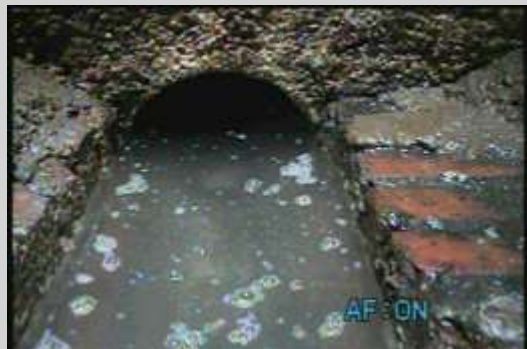
6 O'Clock Inflow

8 in. Circular Gravity Sewer  
Pipe In @ 6 O'Clock

Pipe Material: **Clay** ☐ Pipe Lined

Invert Depth: **10.21** (ft.) Flow Characteristics: **None**

Infiltration: **None** Pipe Seal Cond: **Unknown**
